# Our First DISTRIBUTION CENTER

## Part Two

### — LARRY’S SHORT STORIES #281 —

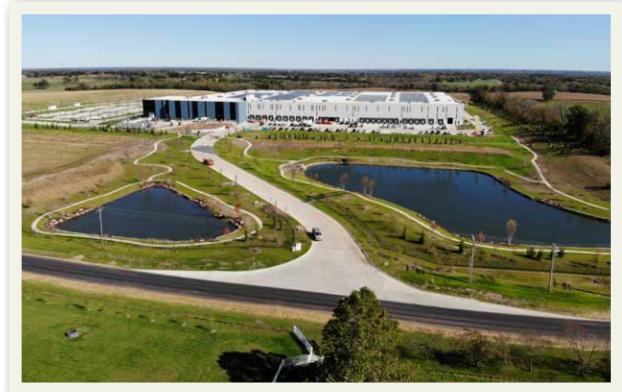
A drone image from the west, showing the trucker’s entrance, dock doors and water retention pools. The blue corner on the left is offices and break room. Air conditioners and solar panels are visible on the roof. Some of the landscaping is visible. Photo by Jarrod Schwartz 10-26-21.

The roof/ceiling is an underappreciated part of a building; the top half (the roof) is completely out of sight. It catches the rainwater and funnels it to the water retention basins.

on which the 30 air conditioning units and the 4,000 solar panels sit, it contains the insulation, and most importantly, it helps hold the building together —

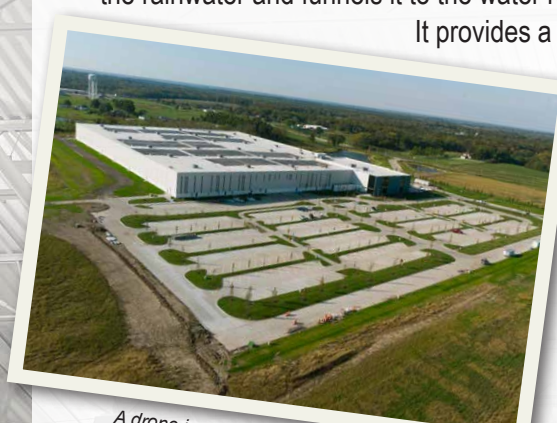
A drone image from the north, showing Employee parking lot north of the building and expansion area to the east. Landscaping mostly in place. Image by Jarrod Schwartz 10-26-21

One last thing, our new 400,000 sq. ft. Distribution Center is expandable; the east wall is movable and the land to the east has already been prepared for a 300,000 sq. ft. addition, sometime in the future. That’s the end of Part II.
